## Fire safety onboard

By Warren Garner

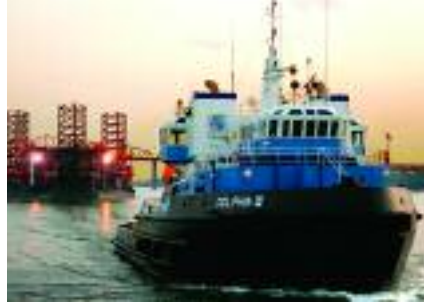
In the fall of 2004, the *Dolphin III* sustained a fire in the engine room. Contained within the upper and lower engine room, the inferno buckled the surrounding steel, bulkheads and smokestack, melting almost everything in the rooms. The precise origin of the blaze remains a mystery, according to Dolphin Marine International, because the engine room was too damaged to identify its cause.

The *Dolphin III* returned to sea in April

"In the engine room the fire had bowed out the steel bulkhead more than two inches, the copper tubing had melted all the way through and there was absolutely nothing left of the transit," he said. "But on the other side of bulkhead, where the RISE system had protected, the copper transit still appeared completely untouched and new."

After 95 days of repair work, a main engine overhaul, extensive tests and sea trials, and ABS requirement certification, the *Dolphin III* went back to work in April 2005 and has been active since.
